1234 ANY STREET, PITTSBURGH, Pa 12345
Inspection prepared for: ANY CUSTOMER
Real Estate Agent: JR Sergeant jr - Howard Hanna

Date of Inspection: 12/2/2017 Time: Start 9.00 am, finished at 12.00 noon

A basic visual home inspection with a wood destroying inspection, a Radon test(48 hrs) and a Mold test was performed.

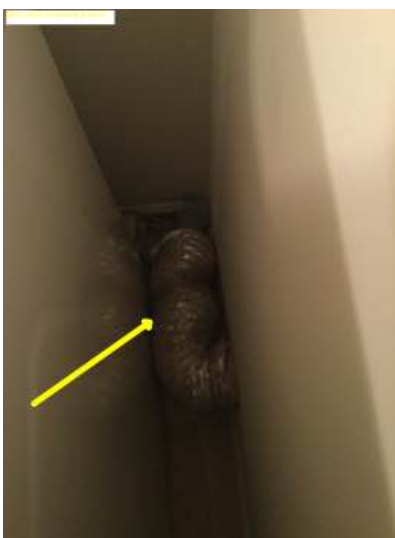
Dryer vent

- The dryer vent pipe is crushed in spots. This should be replaced due to the fact that lint can accumulate in the crushed areas and catch fire.

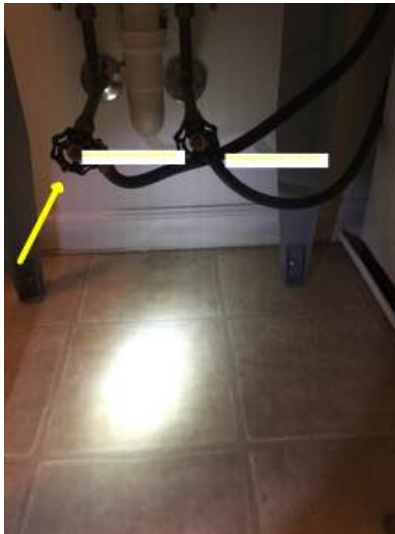
- Supply lines are copper and the waste is abs.
- Washing machine hose leaking at hookup

Leaking hot water hose connection

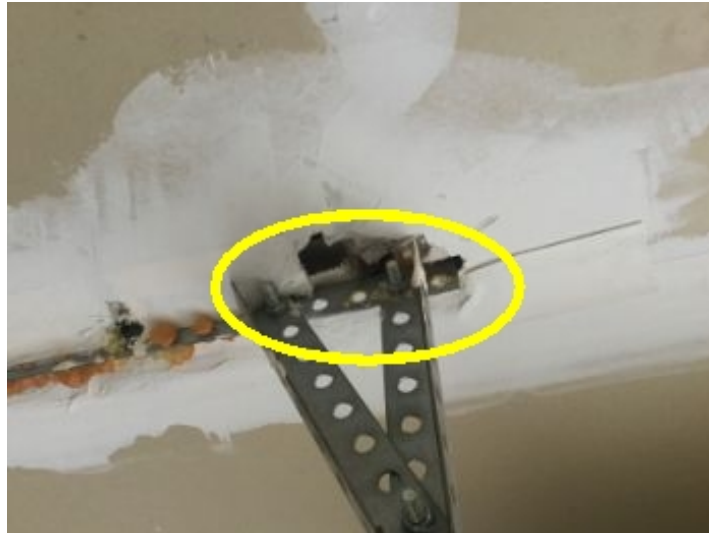
- Fire wall between garage & house not continuous.

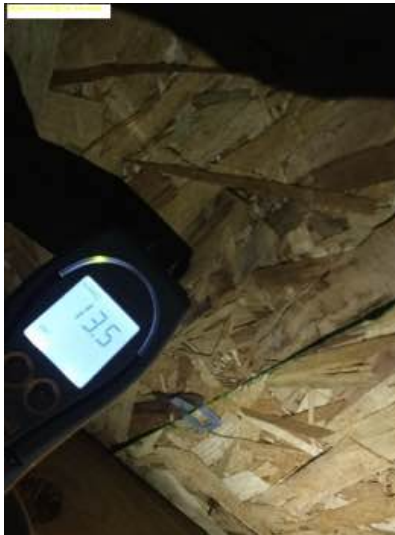
Roof deck

- Evidence of past or present leaks, dry at time of the inspection. Monitor for leaks &/or have roofing contractor evaluate.
- The Roof structure consisted of two by four trusses spaced twenty four inches apart with osb covering the deck

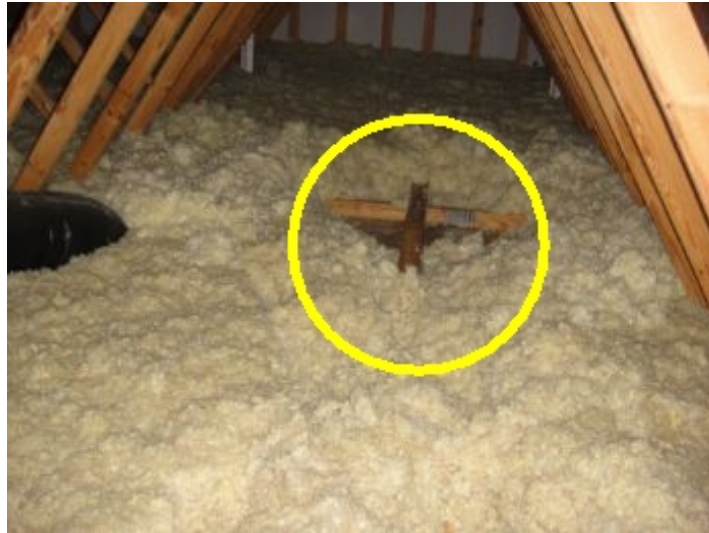
Materials: Loose fill insulation noted.
Depth: Insulation averages about 14-16 inches in depth
Observations:
• Insulation level in the attic is typical for homes this age
• sparse in some areas

sparse in some areas

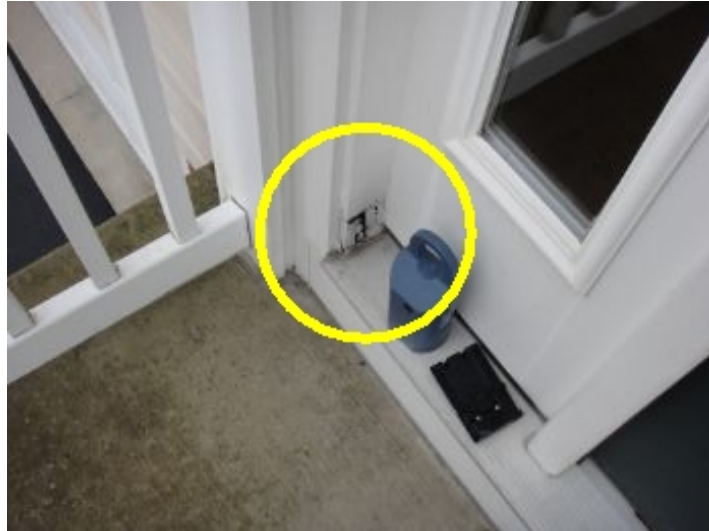
The front door surround/trim is wet and deteriorating due to moisture intrusion. Paint all bare wood to prevent wood rot.

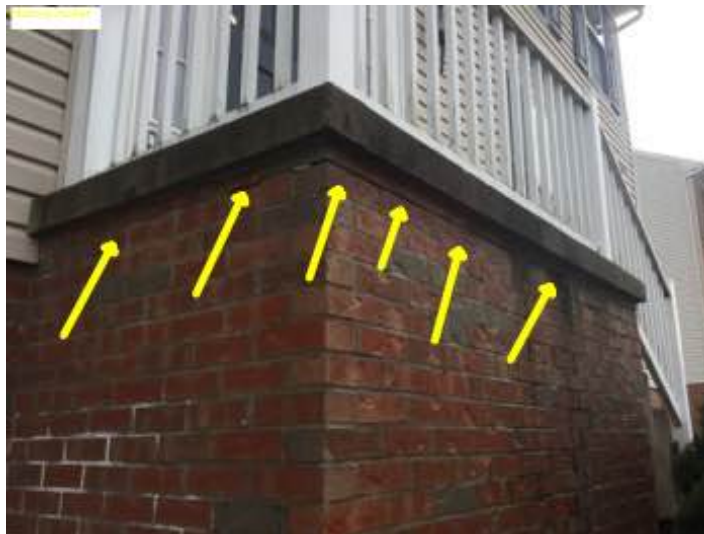
Porch landing

- There is a masonry open porch with concrete landing and stairs that leads to the front door.
- Missing mortar under landing caused by frost/water infiltration. Recommend masonry contractor repair.

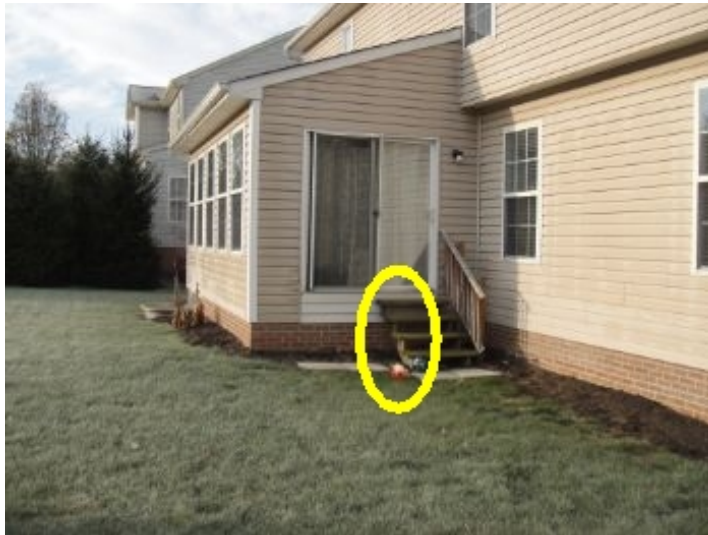
Missing handrails and balusters.

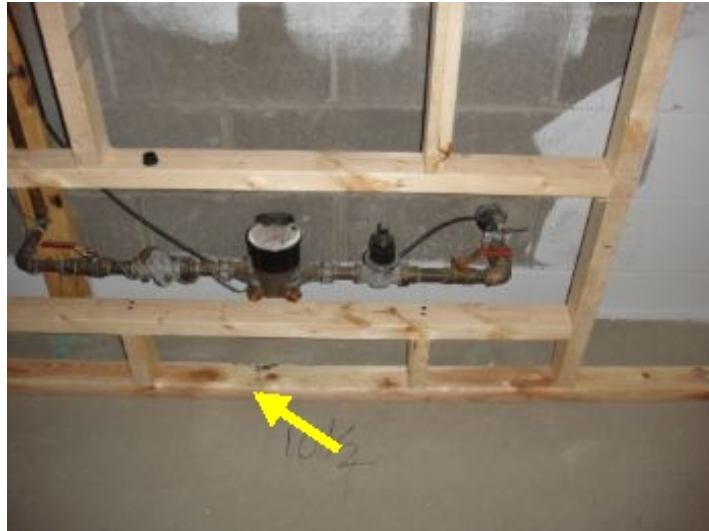
Bare wood in touch with masonry needs to be treated

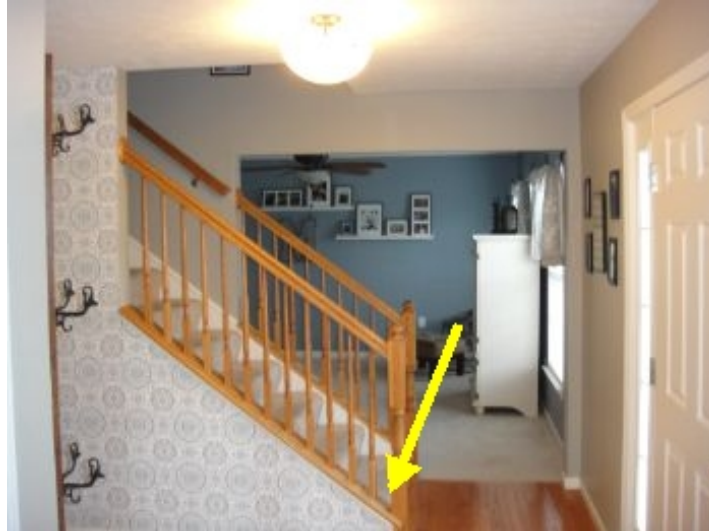
Loose hand rail on left side needs secured

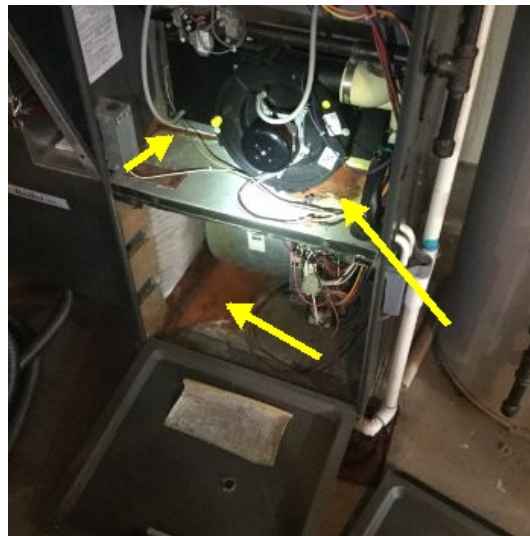
Rust and flaking observed

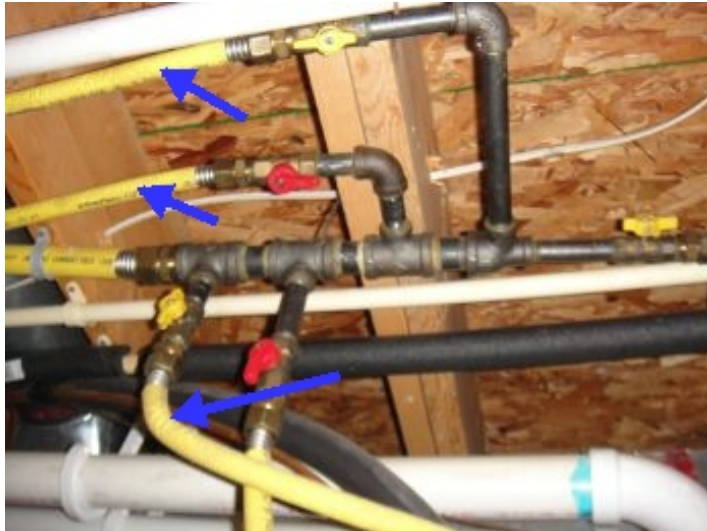
All CSST(corrugated stainless steel tubing) yellow in color needs to be bonded
